# NO CLEAN-UP, **NO JUSTICE**

**AN EVALUATION OF THE IMPLEMENTATION OF UNEP's  
ENVIRONMENTAL ASSESSMENT OF Ogoniland, NINE YEARS ON**

JUNE 2020

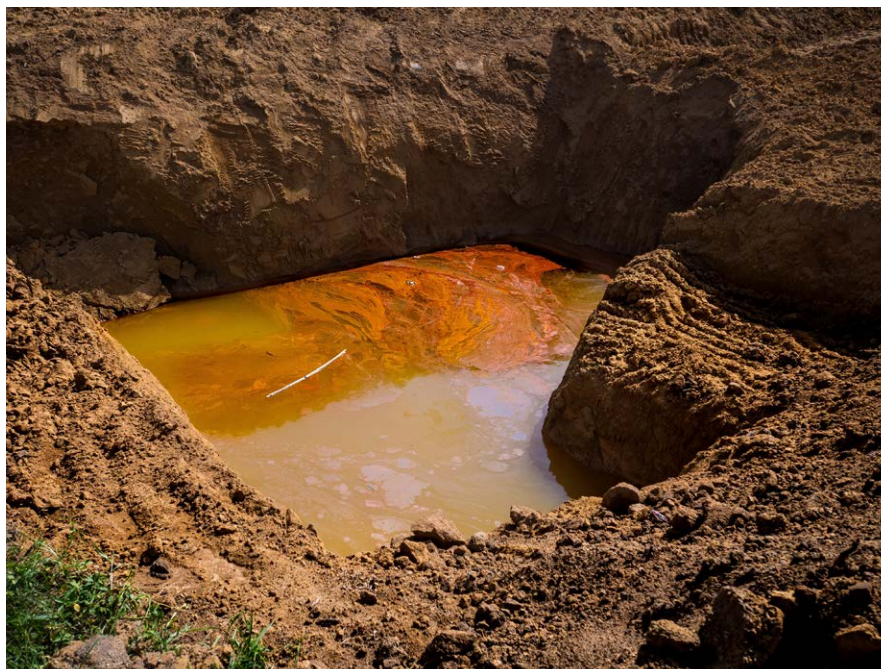
*Lot 10: The excavated trench, with patches of oil and oxidized iron on groundwater.  
© Isaac Harry/cmapping.net  
Date: April 2020*

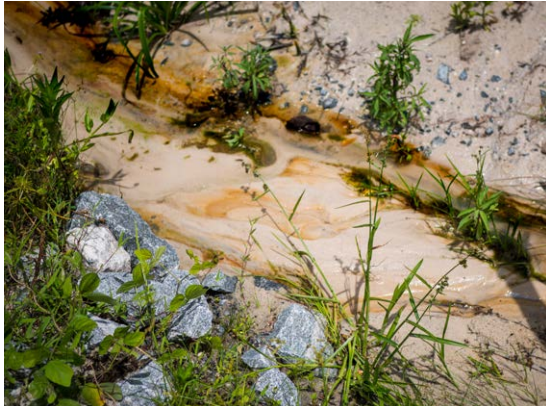
**Lot 9:** Contamination from this lot still appears to be spreading into the surrounding environment. A stream that is still polluted, judging by its visible oil sheen, is flowing from Lot 9 towards other clean up lots and the Patrick water-front in Bodo community. © Isaac Harry/cmapping.net Date: April 2020

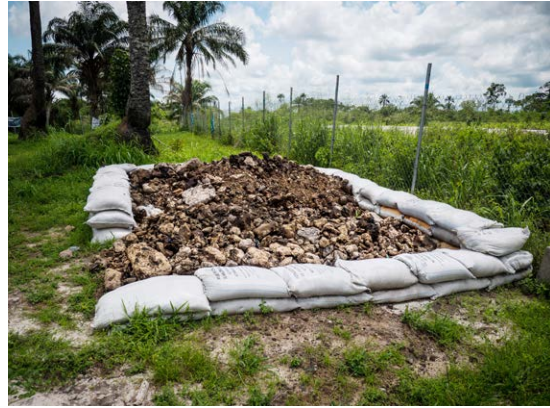
**Lot 10:** Carbonated materials from the site were placed in the open, on the ground without utilizing impermeable HDP material to prevent leaching of these materials back into the soil. © Isaac Harry/cmapping.net Date: April 2020

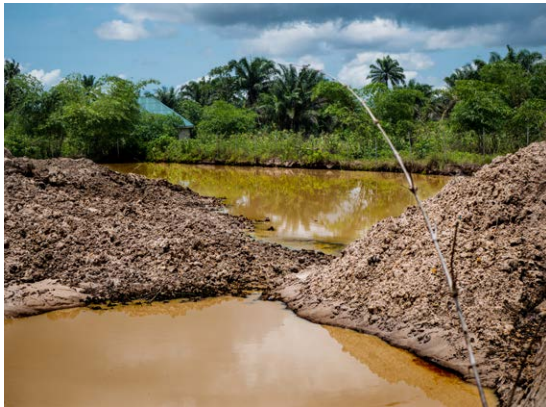
**Lot 10:** Oil is visible on the surface of the water in the excavated area. © Isaac Harry/cmapping.net Date: April 2020

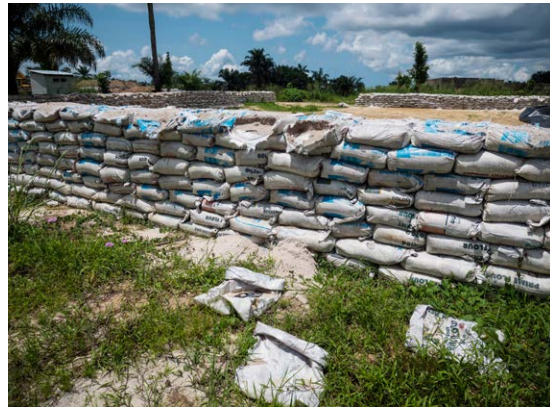
**Lot 11:** The bio cell has been partially constructed but the sand bags used for the bund wall are already torn, compromising its structural integrity. © Isaac Harry/cmapping.net Date: April 2020

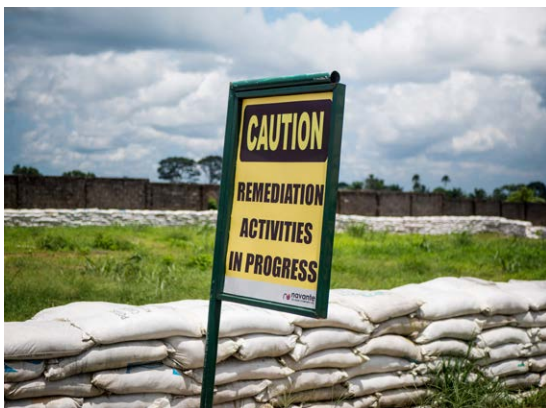
**Lot 14:** There is no activity on this lot and no site office, just some bags of sand. © Isaac Harry/cmapping.net Date: April 2020

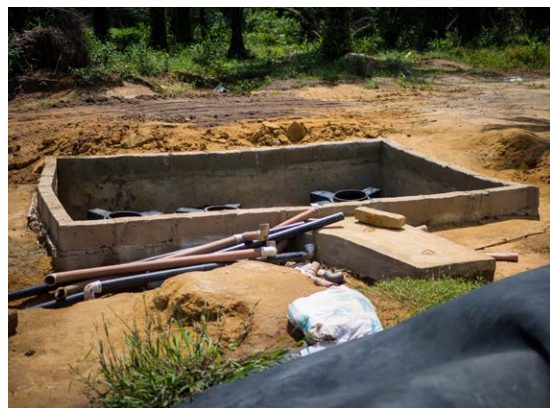
**Lot 16:** The sump is not covered so when it rains heavily it will fill up and overflow. Also pipes carrying water from the bio cell to the sump have failed. Water from the bio cell and sump flooded the surrounding environment after a recent rain incident. © Isaac Harry/cmapping.net Date: April 2020

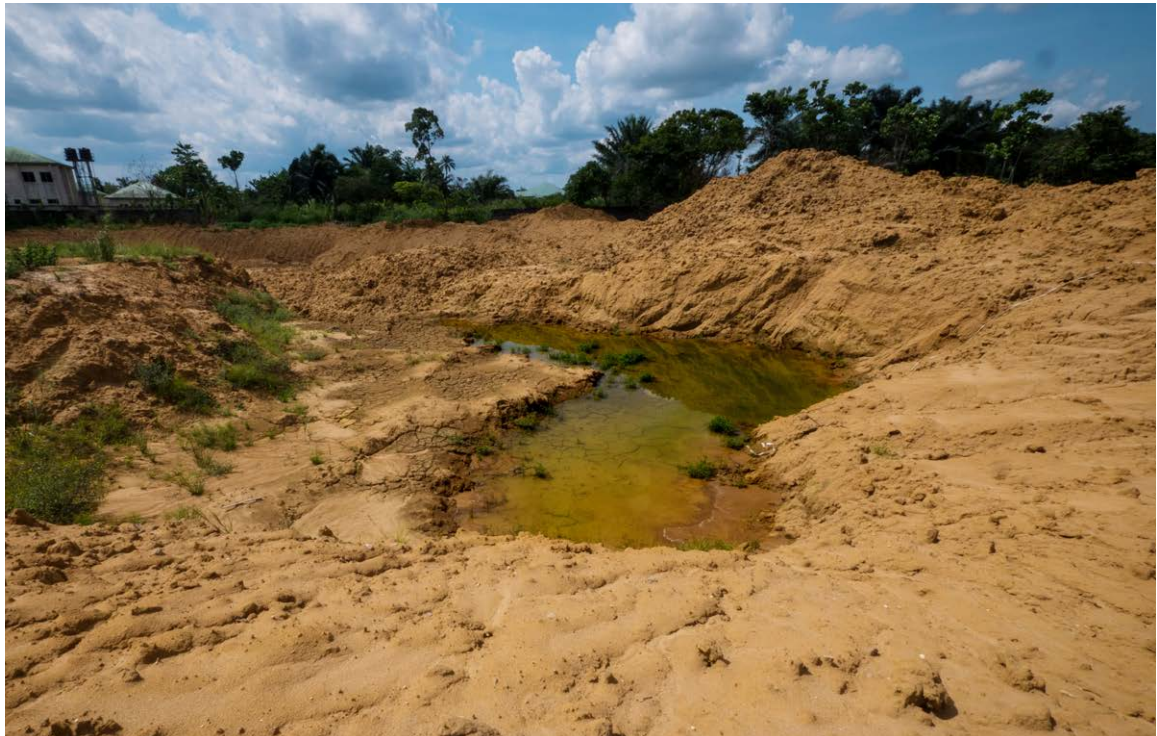
**Lot 19:** Untreated contaminated soil excavated in December 2019 is still in the open and placed side by side with treated soil. Since the excavated area isn't secured or properly separated, contaminated soil is washing into the treated soils around the area and those that have been backfilled in the trenches when it rains. © Isaac Harry/cmapping.net Date: April 2020

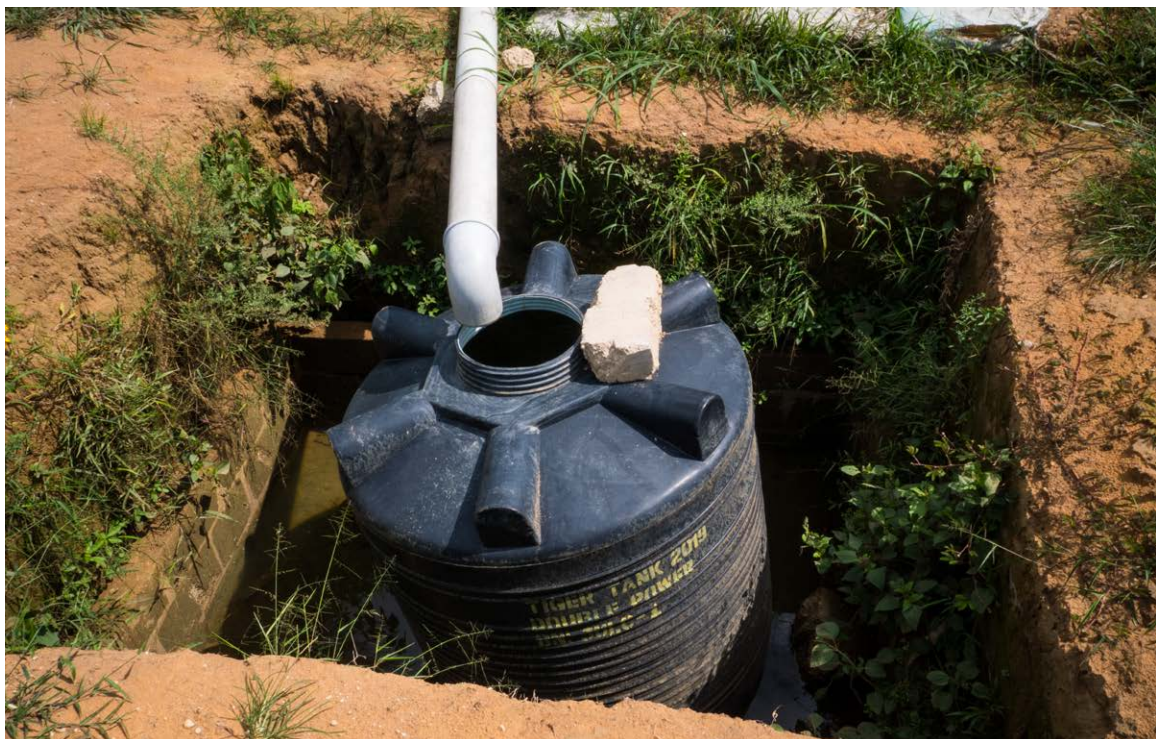
**Lot 20:** Poorly constructed sump. The sump isn't covered so when it rains the sump fills up and spills into the surrounding environment. © Isaac Harry/cmapping.net Date: April 2020
